CITY OF ROME

PHASE I ENVIRONMENTAL SITE ASSESSMENT

FORMER ROME-TURNEY RADIATOR COMPANY – 109 CANAL STREET
ROME, ONEIDA COUNTY, NEW YORK 13440

Issuance Date: August 24, 2015

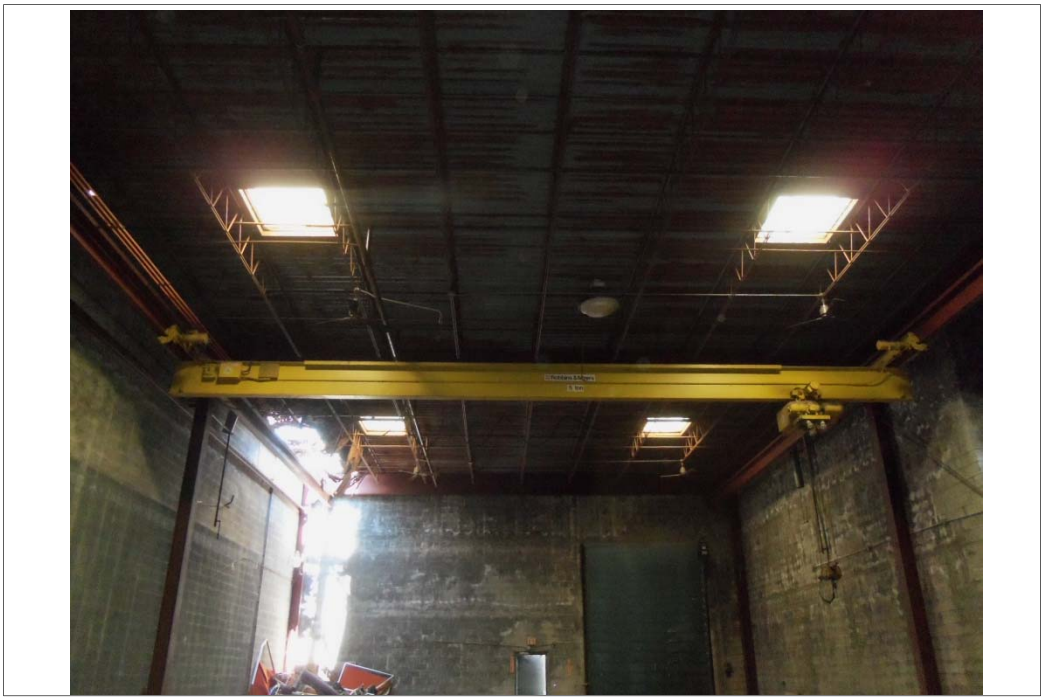
The receiving & shipping area contained an overhead five-ton Robbins & Myers hoist spanning the ceiling, a large pile of debris including paper, cardboard, plastic, oil cans, rolled vinyl sheeting, wood pallets, metal, cloth and miscellaneous garbage, overturned furniture, welding supplies and an overturned box of small electrical components. The floor in this area was stained in places.

Debris pile in receiving & shipping area.

Robbins & Myers hoist in receiving & shipping area.

Debris in in receiving & shipping area.

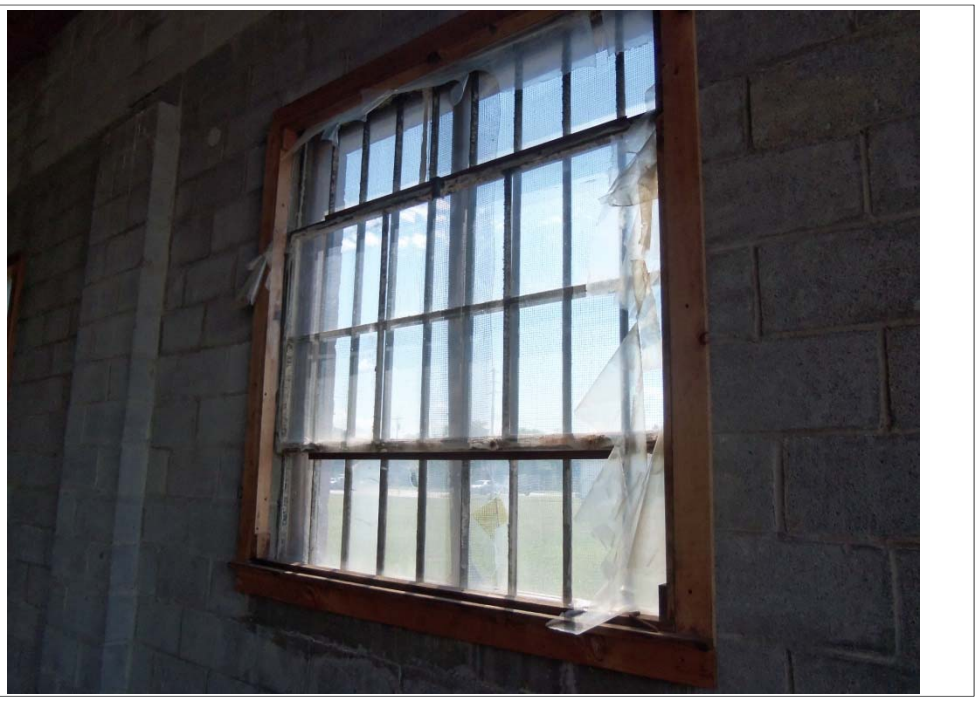
During the site reconnaissance, building debris from a roof collapse was located in the southwest corner of the building footprint. Bergmann's inability to view the building contents in their entirety is considered a limiting condition to this Phase I ESA.

Due to the age of the construction and items observed during the site reconnaissance, ACM is suspected within the building at the subject property. Suspect ACM within items at the subject property is considered a business environmental risk (BER).

Building material in collapsed warehouse section.

Suspect ACM pipe near collapsed warehouse area.

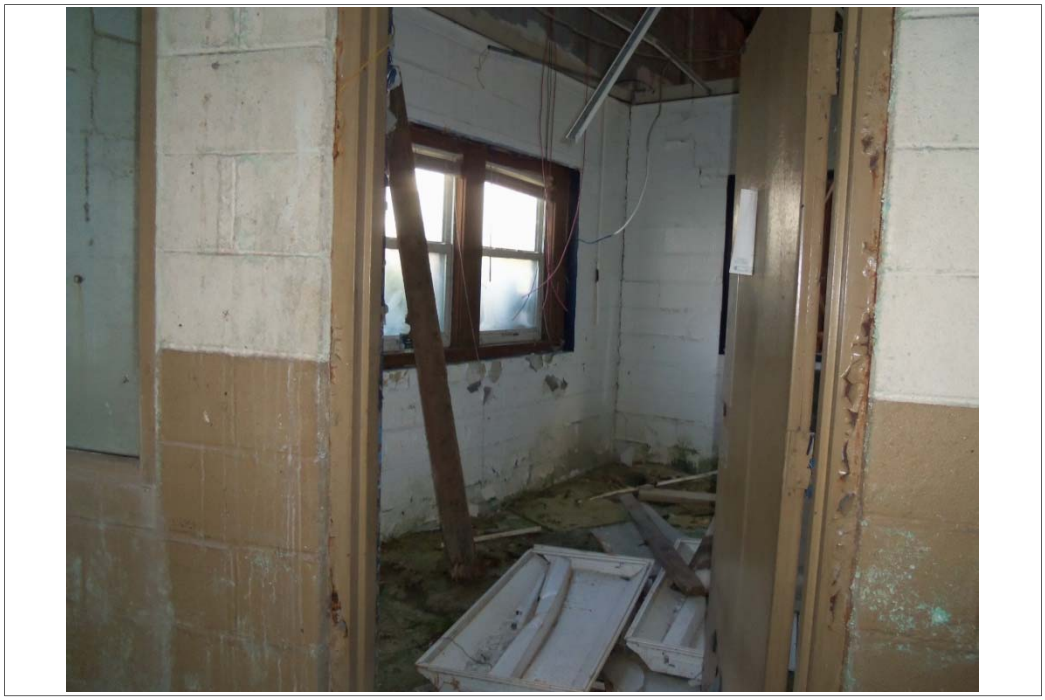
The western production shop contained miscellaneous paper and ceiling, wall and skylight insulation debris from the destruction of partition walls by vandals, a 3' x 9' floor trench and two 8" floor drains. The floor in this area was stained in places and mold growth was visible on floor and wall surfaces and on debris throughout the area. A garage door along the western wall appeared damaged by vandals. A small piece of transite board was located to the west of a partition wall. Transite is suspected to contain ACM. Additional transite board was not observed within the building. Skylights in this portion of the building were broken and the glass was strewn across the floor surface. A block walled room was located in the northwest corner of the western production shop. This area contained general debris; however, the room is labeled as a hazardous materials storage room on a site plan provided in the Site Investigation Report discussed in Section 3.05 of this report.

General view of western production shop west of partition wall.

Floor drain in western production shop.
